# WASH Needs Assessment Report

**Shibam Kawkaban District, Al-Mahwit Governorate, Yemen**  
**Responsiveness for Relief and Development Foundation – RRD**  
**January 2019**

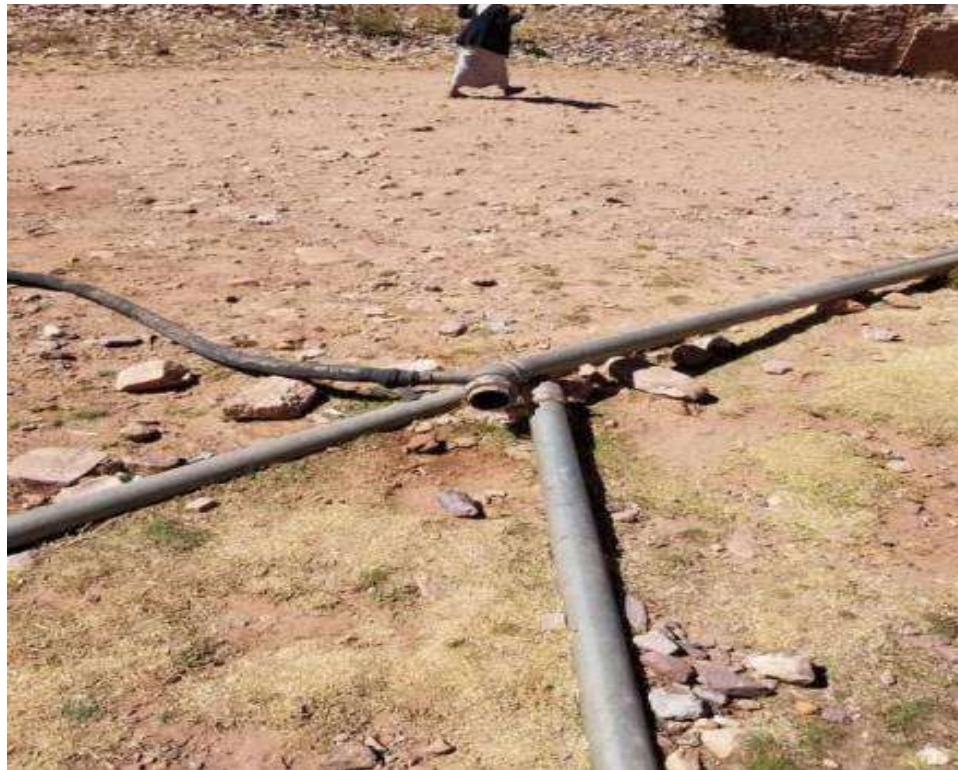
- The destruction of the National Water Supply and Sanitation Authority's building, its warehouses as well as the deteriorating economy and scarcity of financial resources inhibiting the GA to operate and fulfill its roles and duties.
- Worn out water pumping units including generators and submersible pumps that need to be replaced.
- Obsolete spare parts within the water network that need replacement.

**Photo:** Broken pipes connecting the water network

- Provision of solar pumping systems/unit to the six boreholes
- Provision of training and tools to the maintenance teams.
- Rehabilitation and maintenance of the central water reservoir
- Maintenance of the water network.

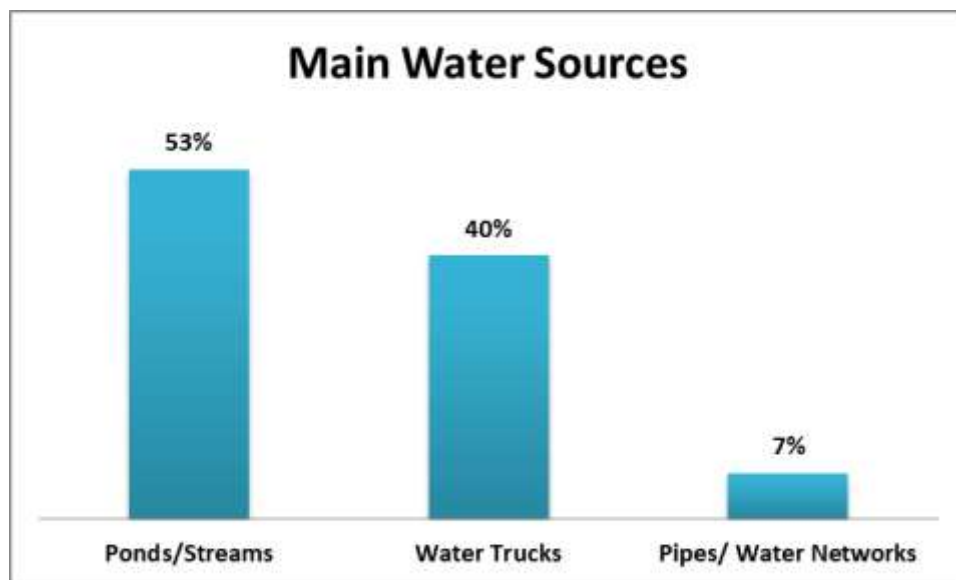
**Figure 05:** Graph presents the proportion of water sources in the community

A summary of the data collected during surveys conducted with 80 individuals randomly selected within the targeted community are presented in the following graphs.

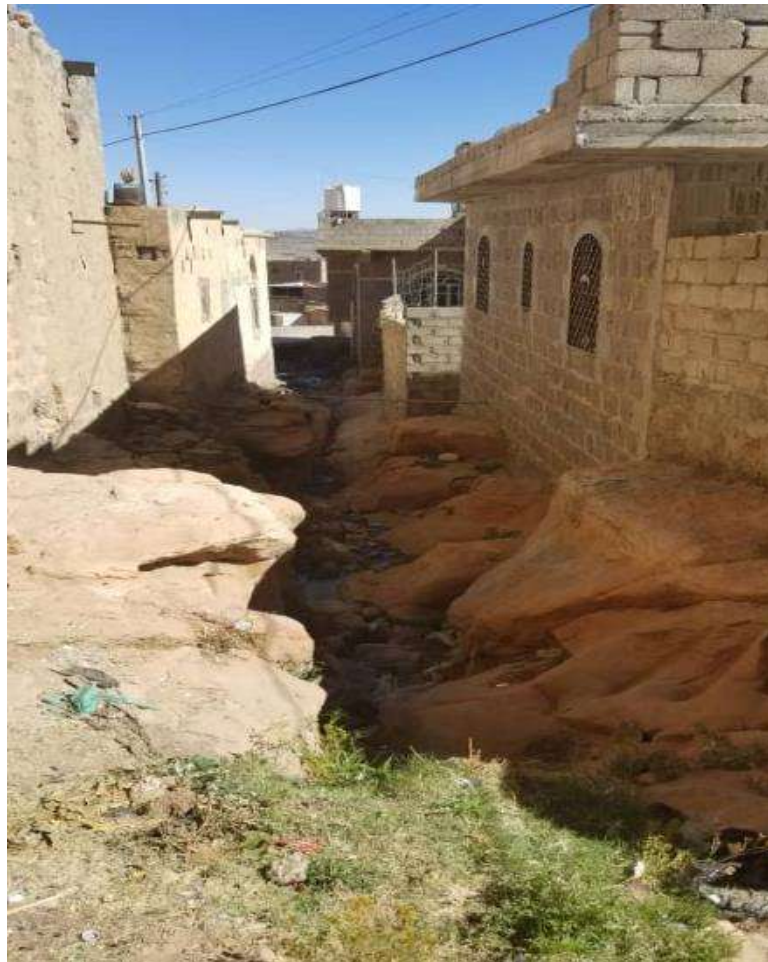
Analysis of data collected during surveys and FGDs with members of the local authority showed that despite the existence of a sewage network in Shibam City, several leakages and discharge points were observed and an urgent need of rehabilitation was required. Established in 2003 by the Social Fund for Development (SFD), the network serves approximately 415 households only within the center of Shibam City, while more than 185 households in surrounding areas were not connected to the network and depended either on open drainage for sanitation. Discharging sewage onto public roads and alleys between houses as well as rain streams (flood/water ways) has led to an environmental disaster and a major cause of diseases spreading in the community, in addition to burdens of the unbearable and suffocating odors observed during the data collection process.

**Photo:** Sewage discharge between houses

- Construction of a sewage network for houses that can be connected to public sewer
- Construction of a sewage network and linking them with cesspits (septic tanks) for houses that cannot be connected to the public network
- Maintenance and Rehabilitation of the sewer trucks owned by the National Water and Sanitation Authority.

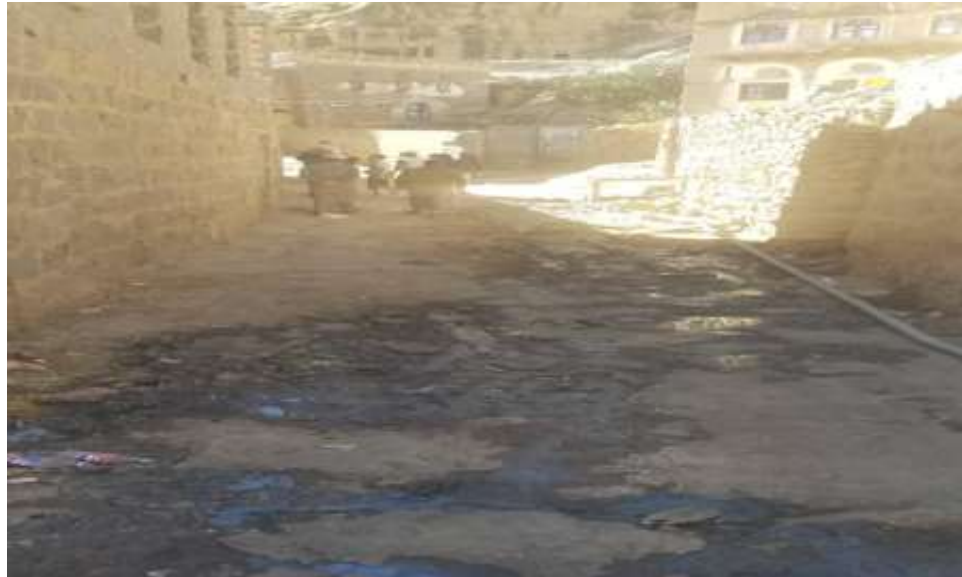
**Photo:** Sewer drainage between houses in the community

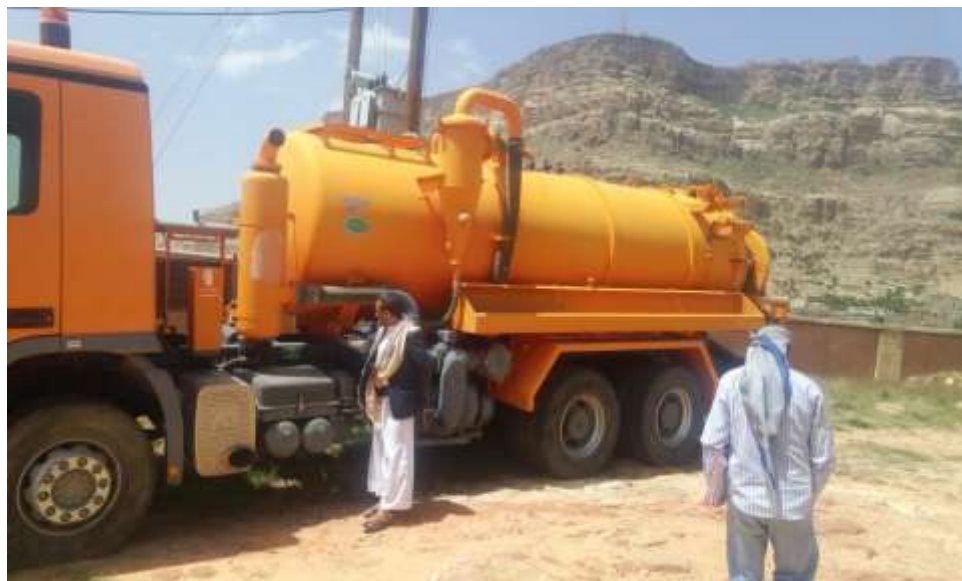
**Photo:** General Authority's sewer trucks in need of maintenance

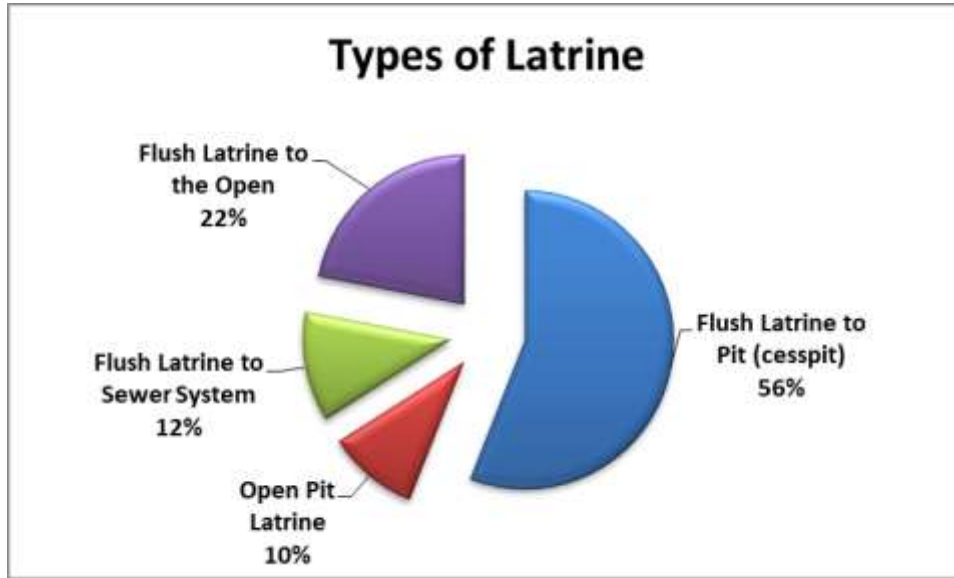
**Figure 10:** Graphs of types of toilets in the community

While 100% of interviewed respondents reported having toilets accessible to members of their family, the following graph presents the varied types of toilets available in households within the targeted community.

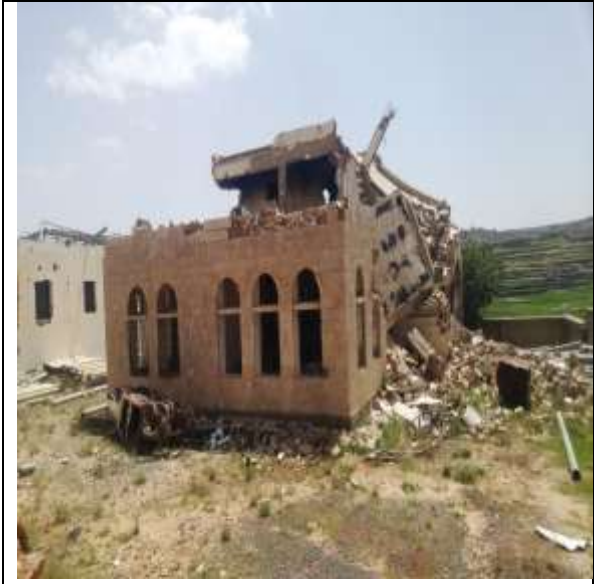
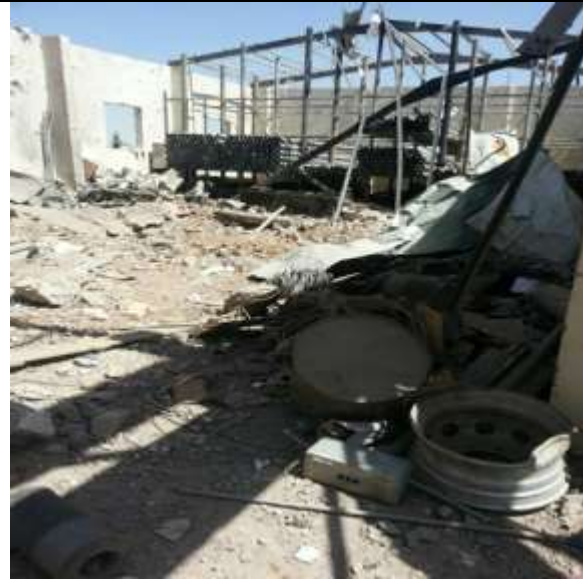
*Airstrikes caused major damages to the National Water and Sanitation Authority's building in Shibam Kawkaban District, Al-Mahwit Governorate.*

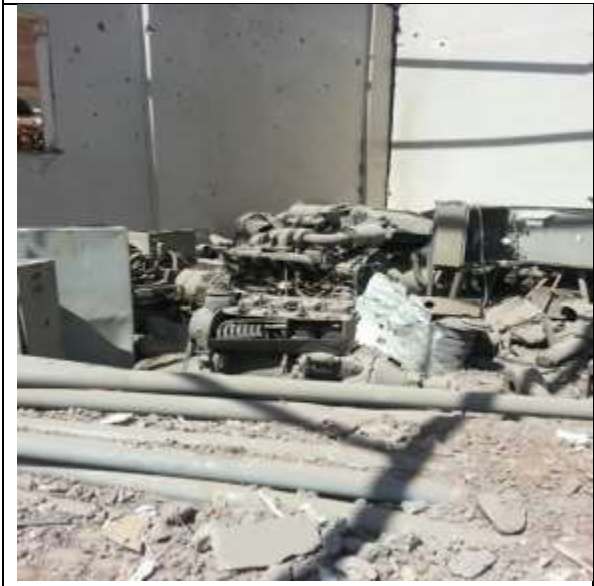
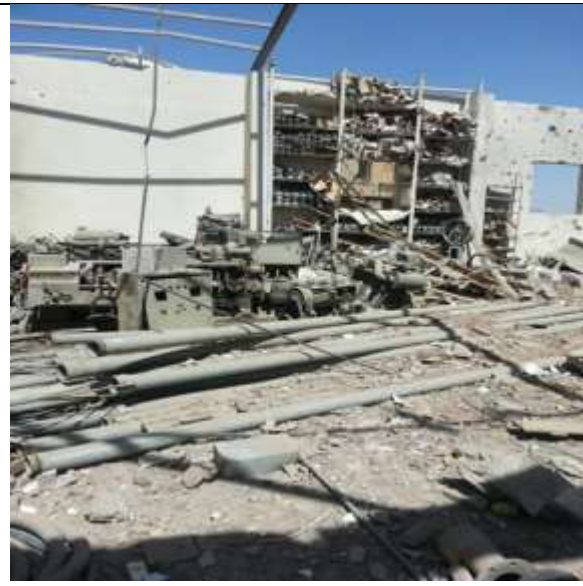
*The National Water and Sanitation Authority's warehouses and maintaince units after being targetd with the airstrikes.*

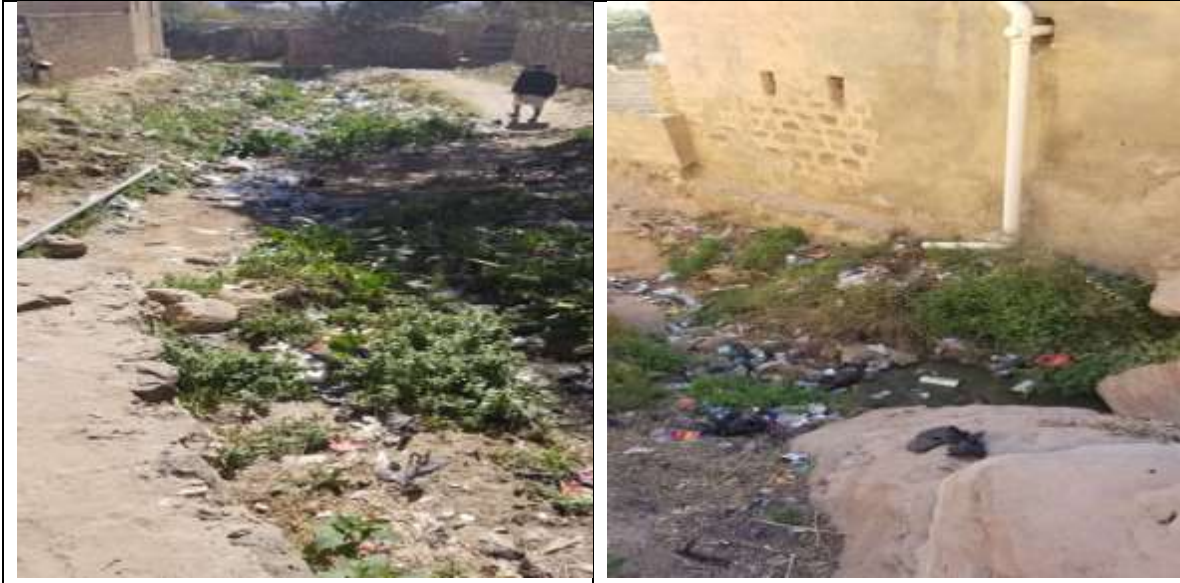
*Open drainage observed next to houses in Shibam City.*

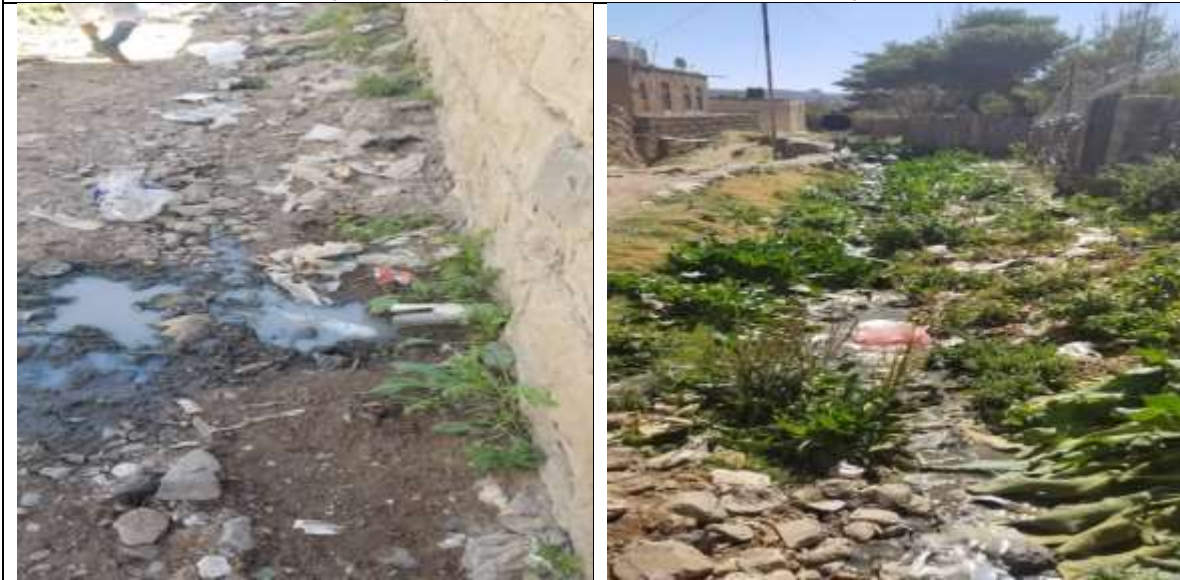
*Sewage discharge between houses as well as rain/water streams in Shibam City.*

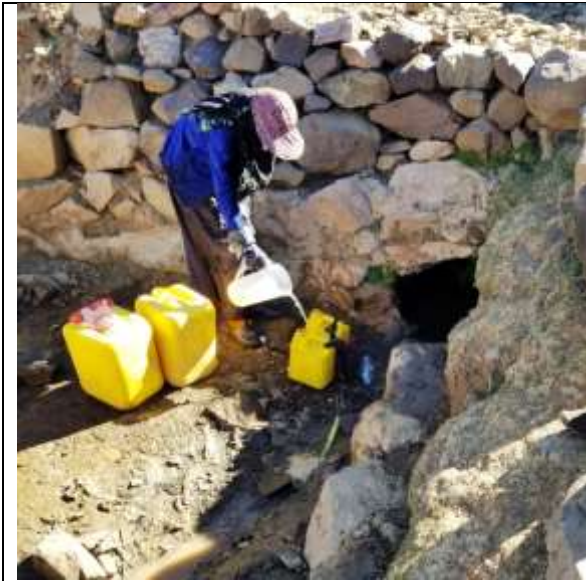
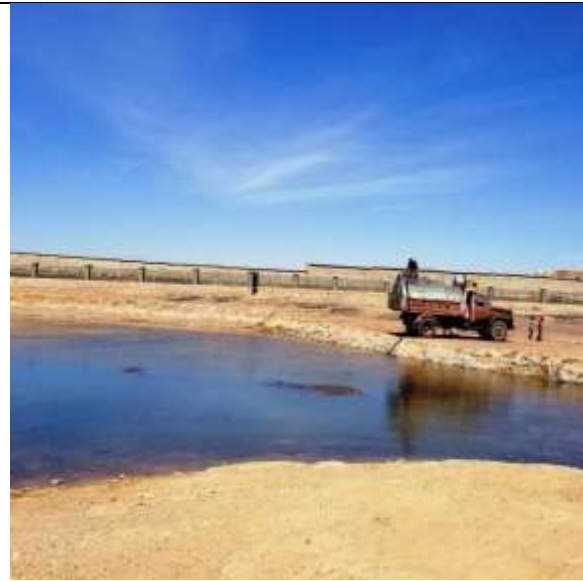
*Ponds and water springs are the main source of water for majority of the community members in Dhela' sub-district.*

*Water trucks collecting water from rainwater sold as safe, clean water to members of the community in Kawkaban sub-district.*

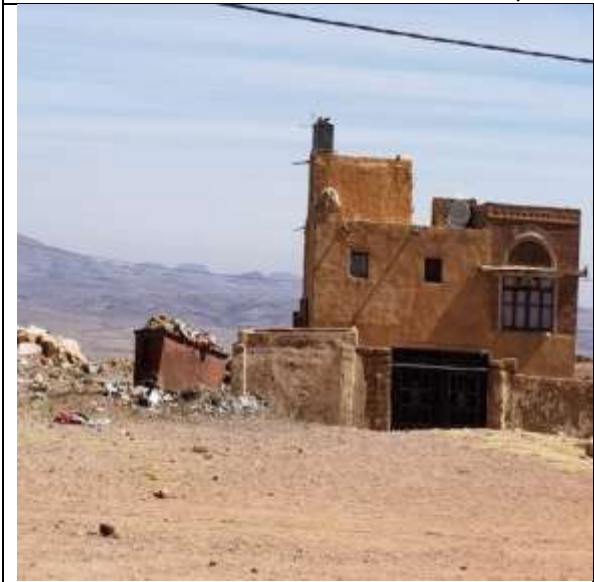
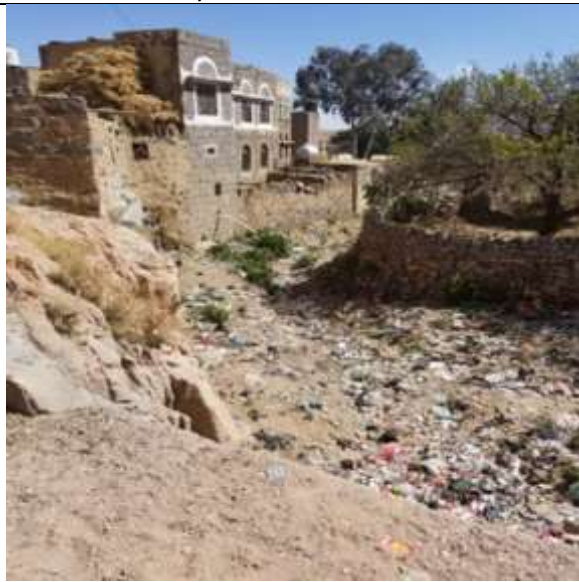
*Random garbage disposal commonly observed around the district.*

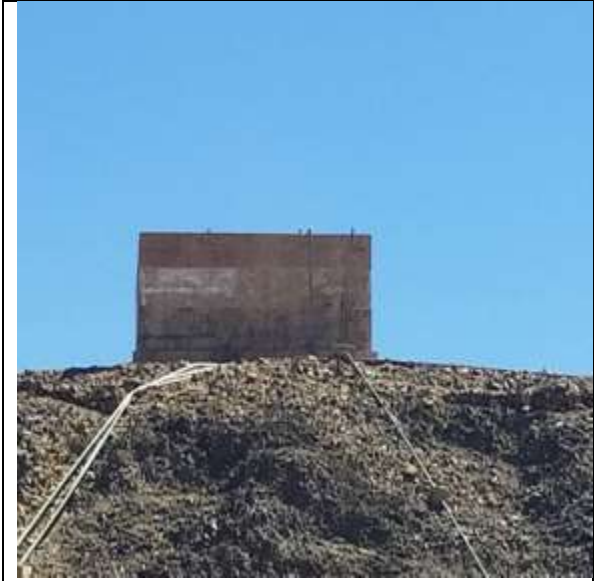
#	Name	Type	Capacity	Status	# of Beneficiaries	Water Source
1	Bait Maleek	Ground	200	In need of Rehabilitation	6,691	Bait Maleek Boreholes
2	Bait Mofareh	Ground	150	Good	7,827	
3	Bait Qeerah	Ground	100	Good	786	
4	Al-Zakateen	Ground	65	Good	413	
5	Bait Khamis	Ground	50	Good	906

*Water tank in Bait Maleek, Dhela' sub-district, Shibam Kawkaban District, Al-Mahwit Governorate.*

- Provision of solar pumping systems/unit to the eight boreholes.
- Provision of training and tools to the maintenance teams.
- Rehabilitation and maintenance of the central reservoir
- Maintenance of the water network.

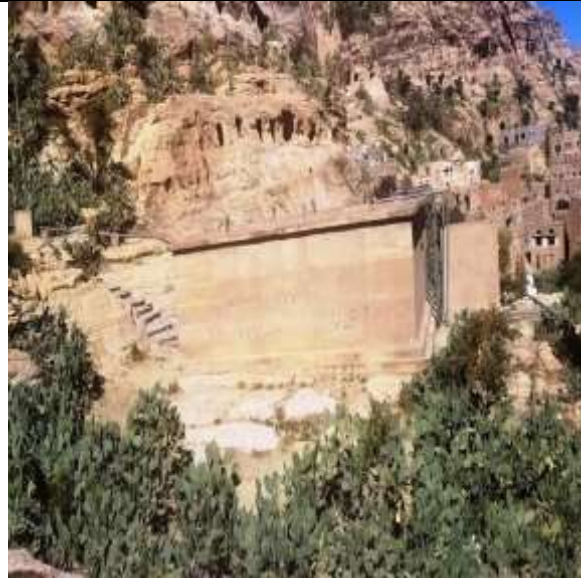
#	Location	Type	Capacity (in M3)	Status	# of Beneficiaries	Water Source	Comments
1	Shibam	Ground	400	Needs Rehabilitation	15,815	Fed by the wells in Shibam	
2	Kawkaban	Tower	100	Good	2,953		
3	Kawkaban	Ground	200	Good			
4	Wadi Al-Naiem	Ground	50	Good	2,610		
5	Hawshan	Ground	100	Good	-		Used for re-pumping
6	Thula	Ground	200	Good	11,656		
7	Al-Serm	Ground	200	Good	5,595		
8	Hababah	Ground	200	Good	14,832

*The main water storage tank in Shibam City, Shibam Kawkaban District, Al-Mahwit Governorate.*
